TWR-19872

Systems Tunnel Linear Shaped Charge Lightning Strike Final Test Report

August 1989

Thiokol CORPORATION
SPACE OPERATIONS

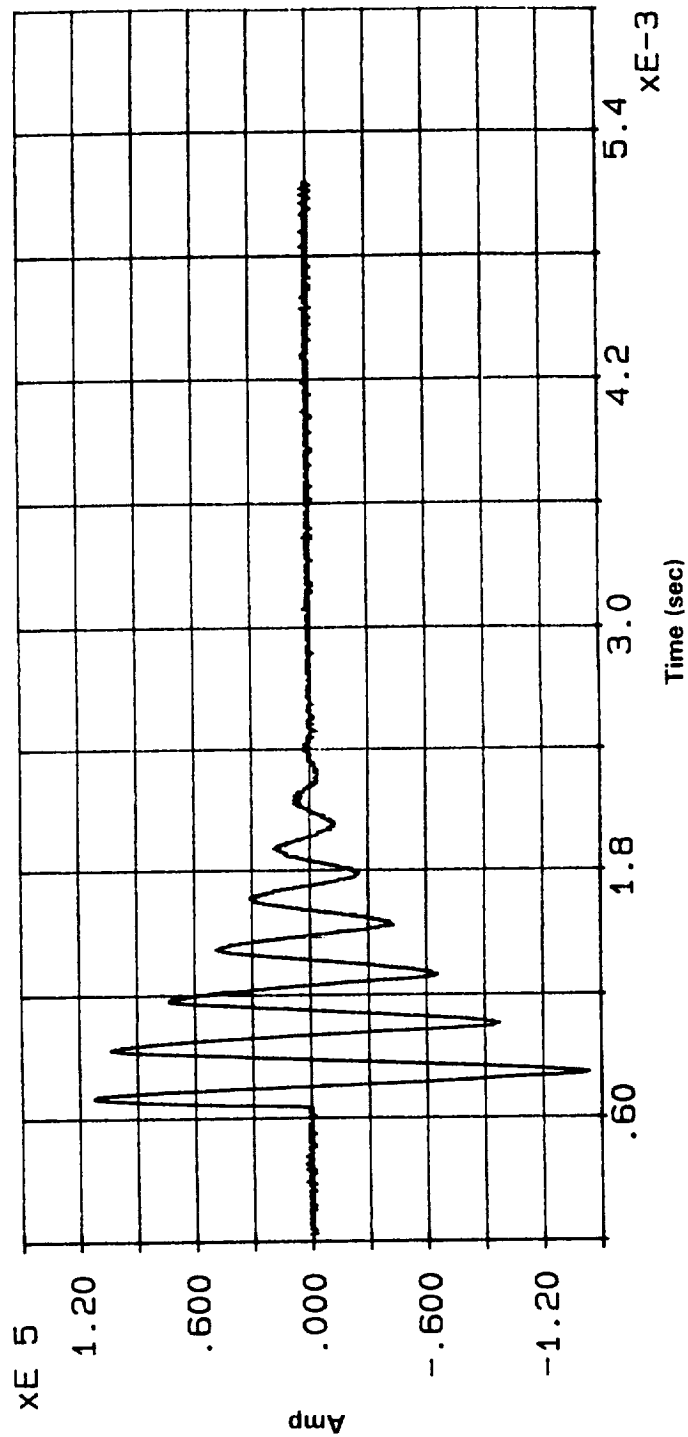
V_0 : 58 kV
Max Current: -143,600 amp
Action Integral: $3.758 \times 10^6 \text{ amp}^2 \text{ sec}$

Figure 6. Systems Tunnel LSC Lightning Strike Test — Current-Versus-Time Plot (second lightning discharge)

Injected currents (143,600 amp) and action integrals ($3.758 \times 10^6 \text{ amp}^2 \text{ sec}$ and $3.685 \times 10^6 \text{ amp}^2 \text{ sec}$) of the second and third tests were very similar. These values were the maximum allowable for the test configuration. The injected currents were 71.8 percent of the NSTS 07636 worst-case condition of 200 kA. The action integrals were approximately 1.85 times greater than the implied maximum of $2 \times 10^6 \text{ amp}^2 \text{ sec}$ in NSTS 07636.

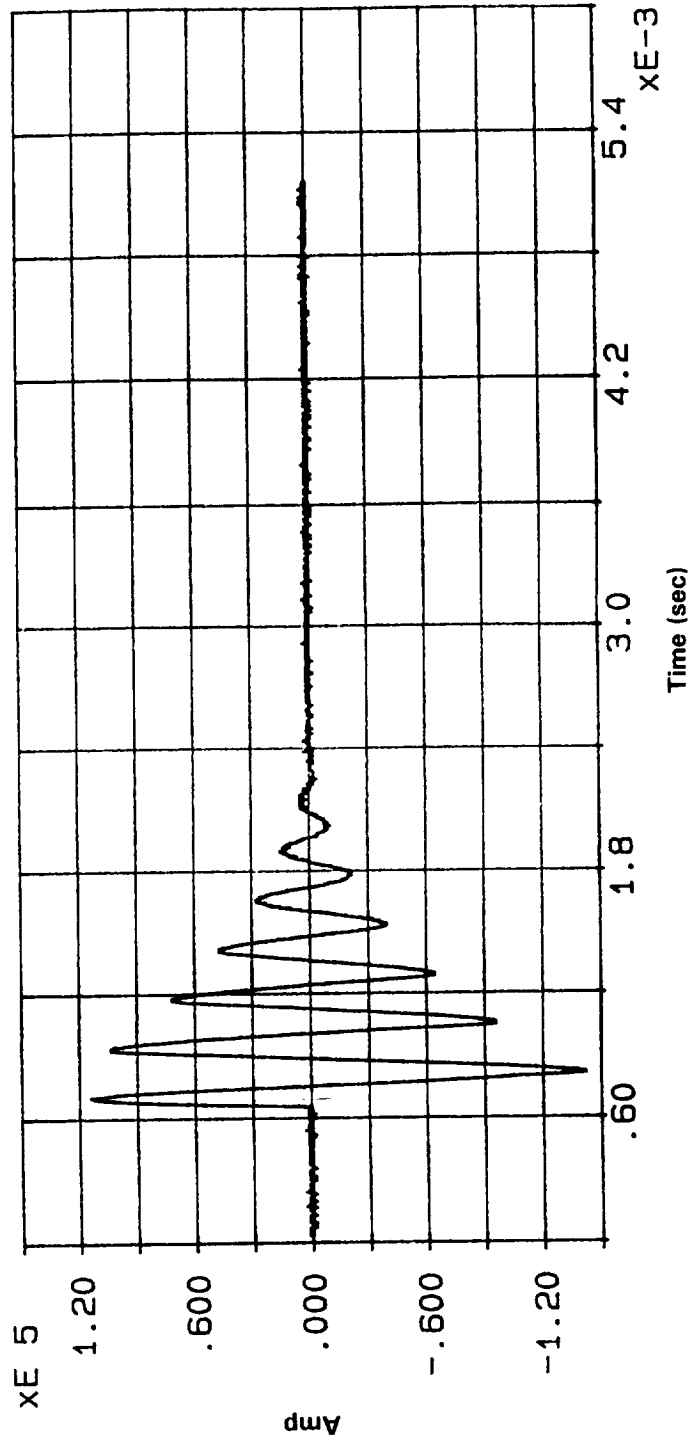
V_0 : 58 kV
Max Current: -143,600 amp
Action Integral: 3.685×10^6 amp² sec

Figure 7. Systems Tunnel LSC Lightning Strike Test—Current-Versus-Time Plot (third lightning discharge)
